Túuši Wána Design Project
Touchet River - Mile 14 – 17

Preliminary Basis of Design
Report

November 2022

*Inter-Fluve
501 Portway Ave
Hood River, OR 97031*

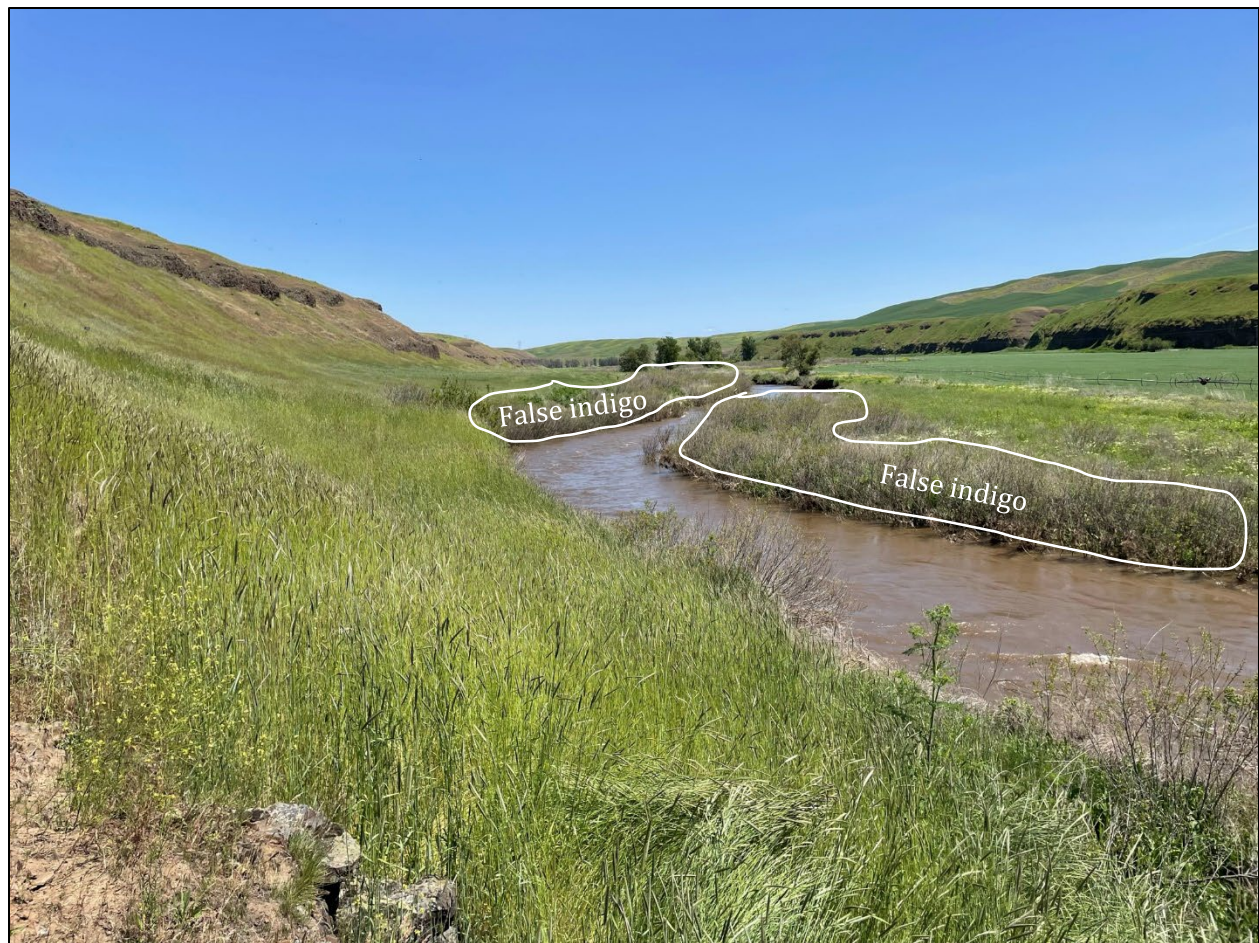
Figure 12 Representative image of False indigo occupying the historical niche of shrub willow (e.g., *Salix exigua*)

Riparian clearing began early in Euro American settlement and has occurred throughout the project area, continuing until at least 1996. This has resulted in an immature riparian community which provides limited shade, limited structure to drive and moderate channel migration, and limited instream wood sources compared to historical conditions. Floodplain aggradation also disconnected large portions of the valley floor from intermediate flood events (e.g., 2-year, 5-year). This, combined with agricultural clearing and grading, has resulted in a valley floor largely devoid of floodplain vegetation assemblages that would be typical of the region’s intermediate floodplain surfaces (e.g., cottonwood). As the floodplain aggraded relative to the channel, smaller inset point bars and floodplains have developed, and today, riparian plant assemblages have occupied these surfaces. Many of these surfaces have been occupied by False Indigo (*Amorpha fruticosa*), which was planted by the Civilian Conservation Corps in an effort to halt stream erosion (J. Gailey, personal communication, May 5, 2022). False indigo now occupies the habitat niche that historically was likely occupied by shrub willows (

Figure 12 Representative image of False indigo occupying the historical niche of shrub willow (e.g., *Salix exigua*)). Field observation and examination of the aerial photo record suggest surfaces were cleared of the remainder of vegetation by the 1970s and consequently contain primarily pasture grasses with few remnant cottonwoods visible from historical flood events.

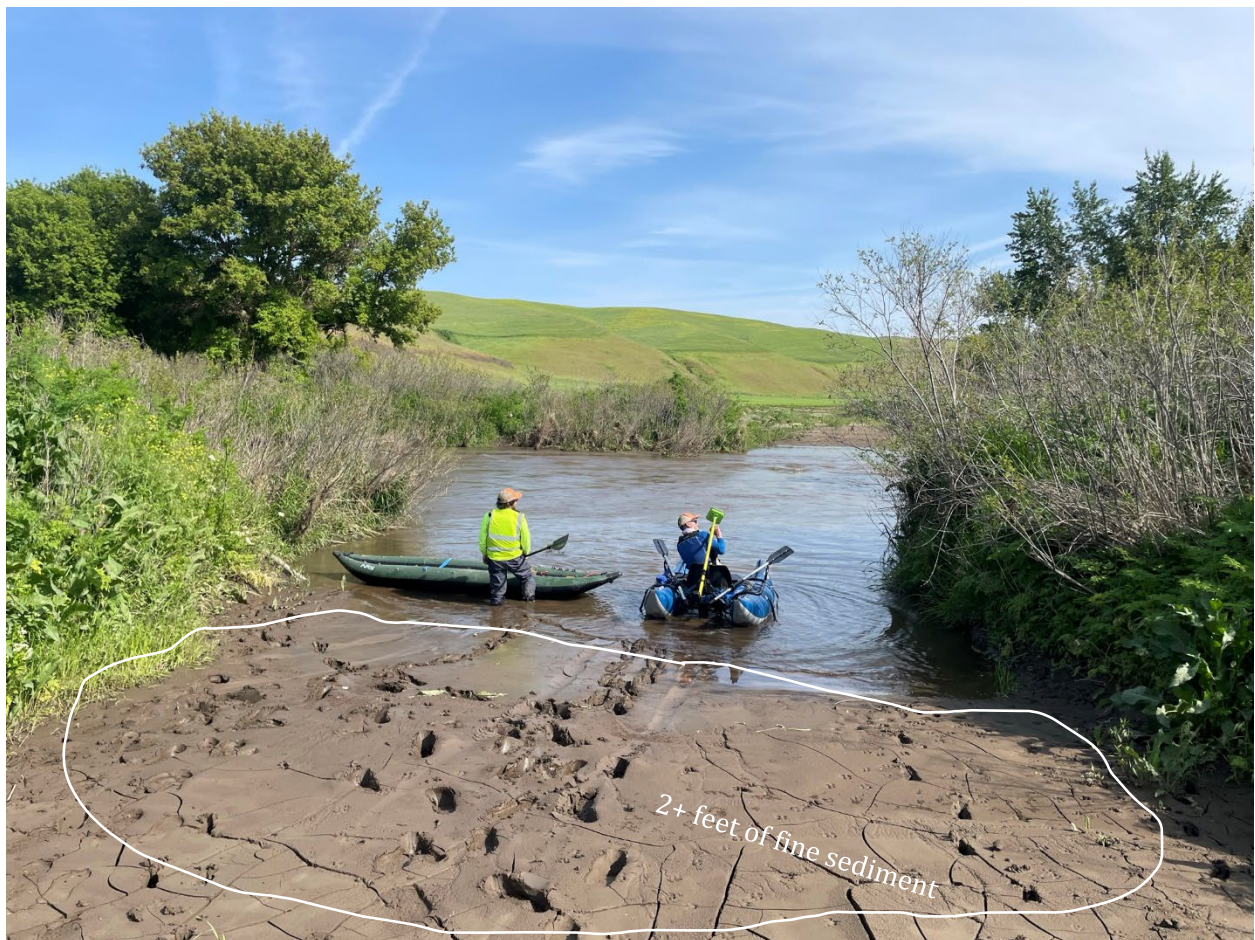
Figure 16 Fine sediment along the banks near RM 15.7

Field observations (bathymetric depth of refusal survey, site assessment (Figure 16), test pits (Table 6) all indicate there is a significant amount of fine sediment that has moved into the system, much of which has infilled atop the historical floodplain surface. These field observations are supported by evidence of erosion in the Palouse and sediment infilling rates related to agricultural clearing in the Walla Walla Basin (USDA 1979, USGS 1998, USGS 1969).
